## Case Report

# Innovative Use of Dermal Substitute for Salvage of Exposed Lower Leg Implant

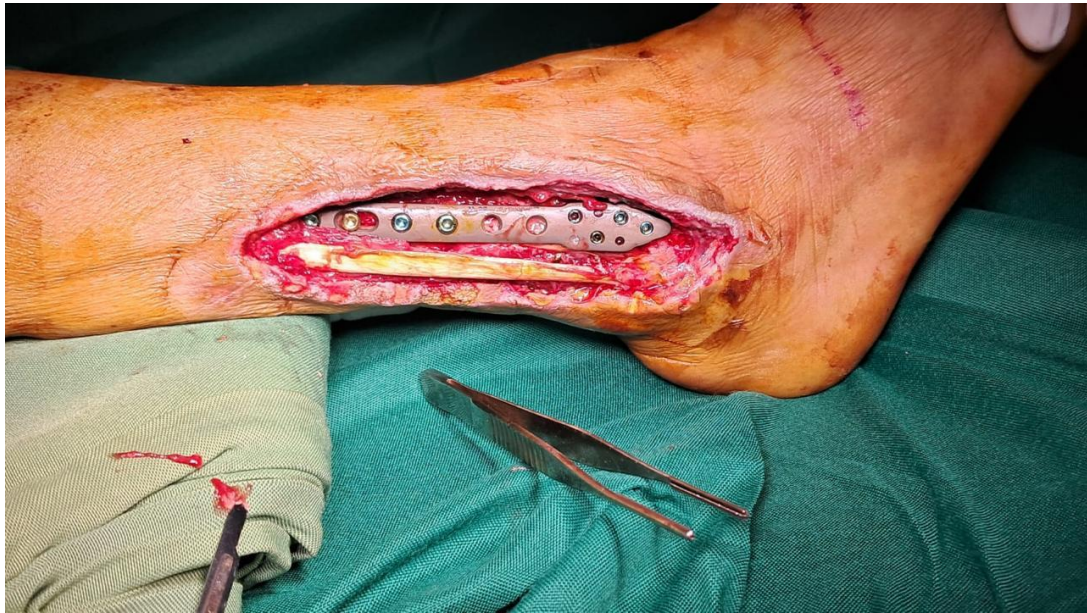
Fig. 1 Exposed implant with fracture site and tendon with pouring pus

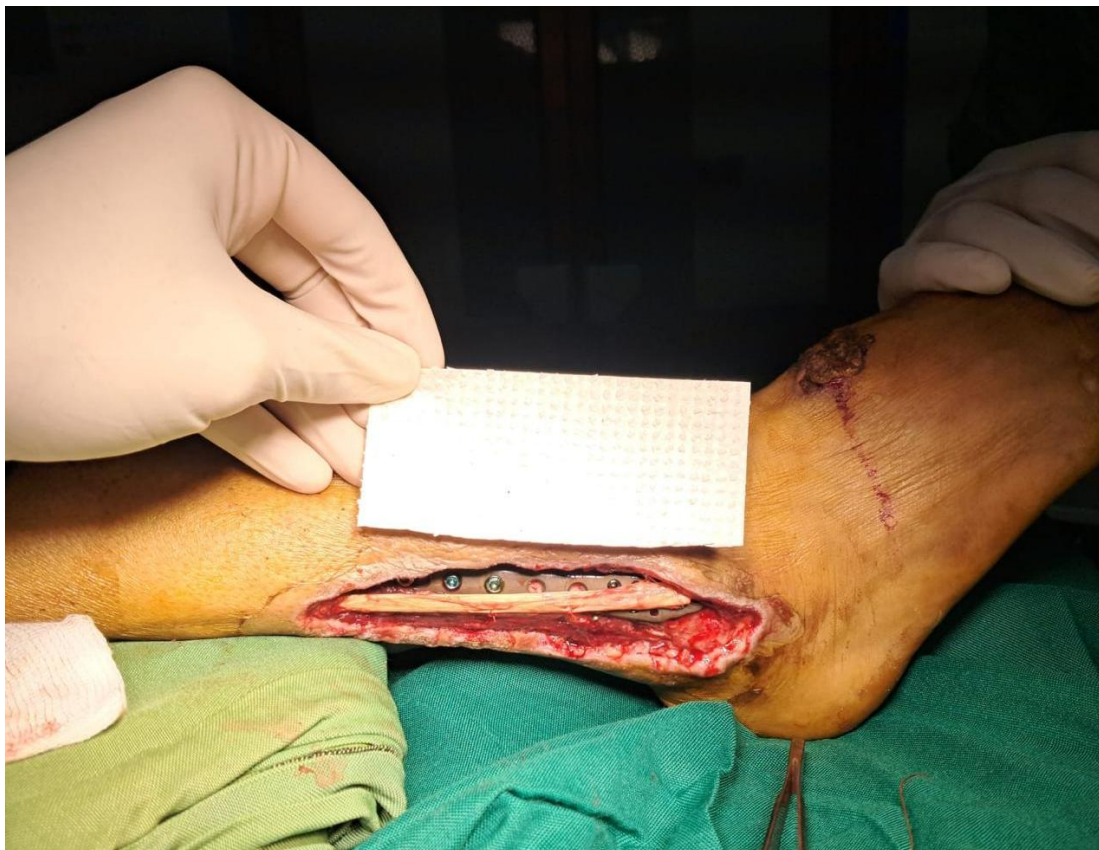
Fig. 2 Exposed Implant covered with dermal substitute and part of peroneus tendon

neodermis formation and coverage. Dermal substitute Myriad Matrix™ is an advanced dermal substitute developed by Aroa Biosurgery, designed for soft tissue reconstruction and complex wound healing. It is made from ovine (sheep) forestomach extracellular matrix (ECM), offering rapid cell infiltration, angiogenesis support, and proven clinical efficacy.

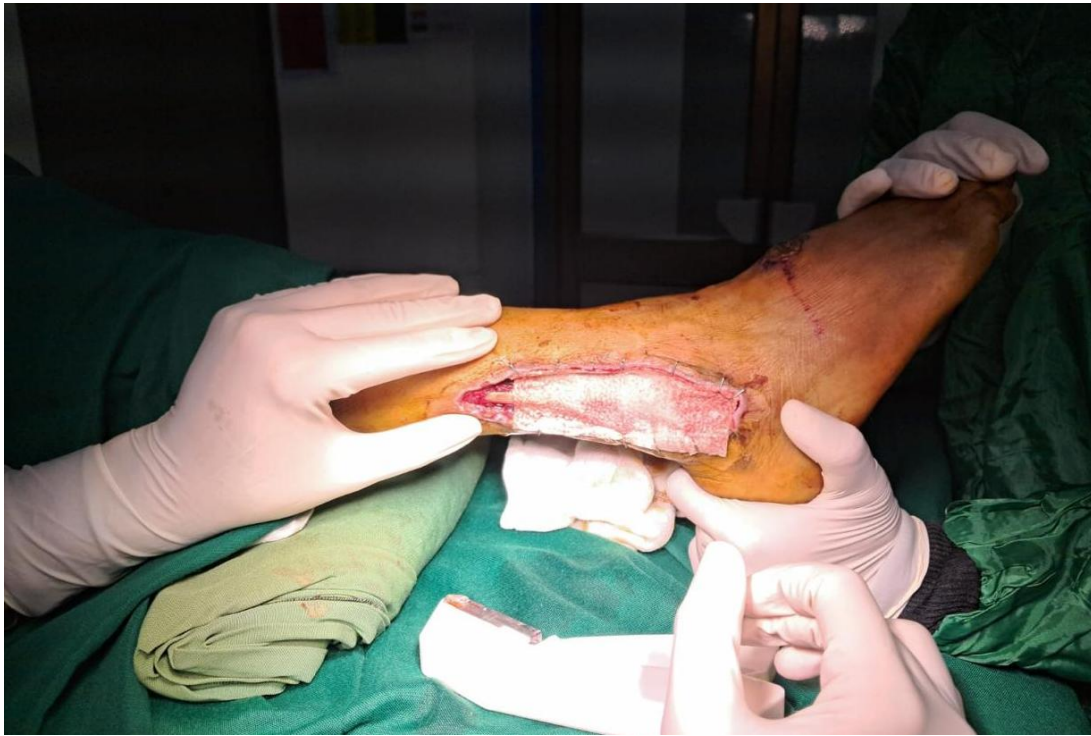
Fig 3. Dermal substitute edges fixed with skin stapler and wound covered

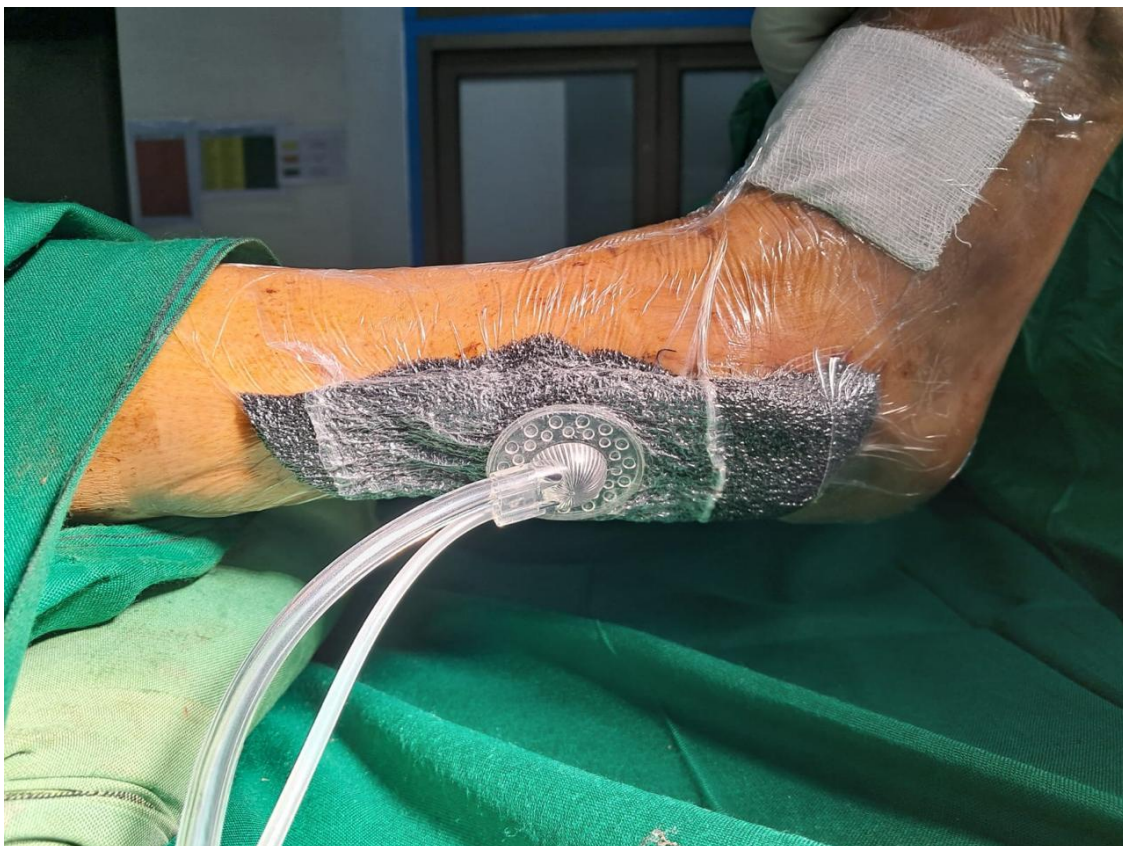
Fig. 4 Negative pressure wound therapy started over dermal substitute

- **Wound Bed Preparation:** Advanced wound care techniques, including negative pressure wound therapy (NPWT), were used to optimize the wound bed.
- **Dermal Substitute Application:** In view of the absence of flap options, a dermal substitute was applied over the exposed implant to facilitate

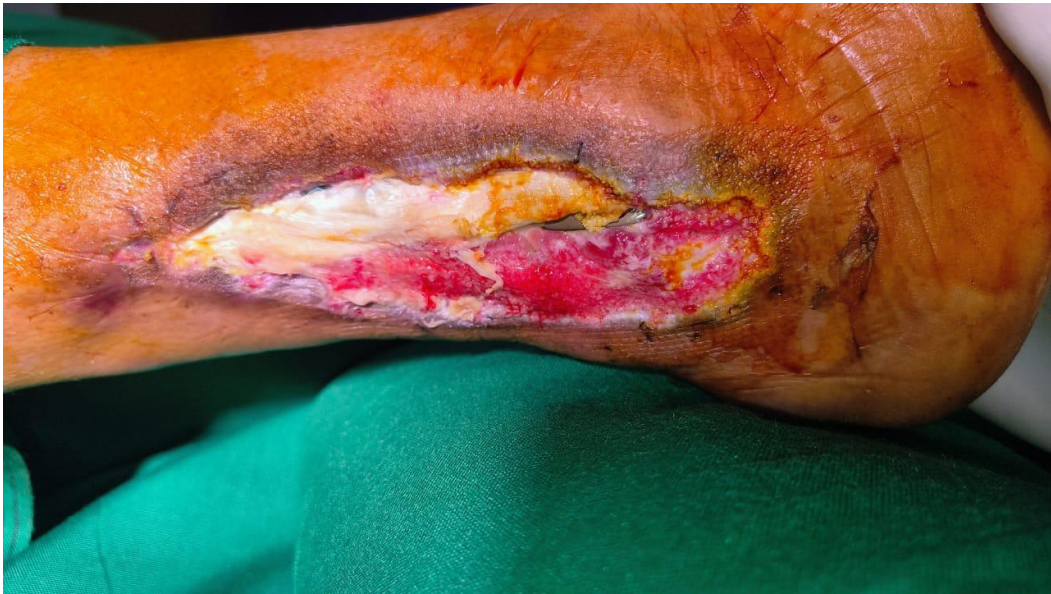
Fig. 5 Remaining Raw area covered with dermal substitute

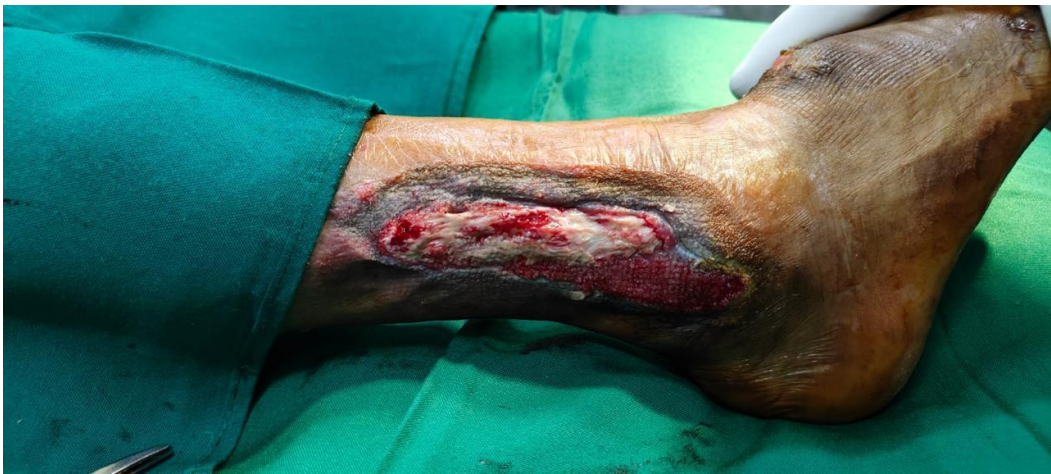
Fig 6 Implant coverage complete with dermal substitute

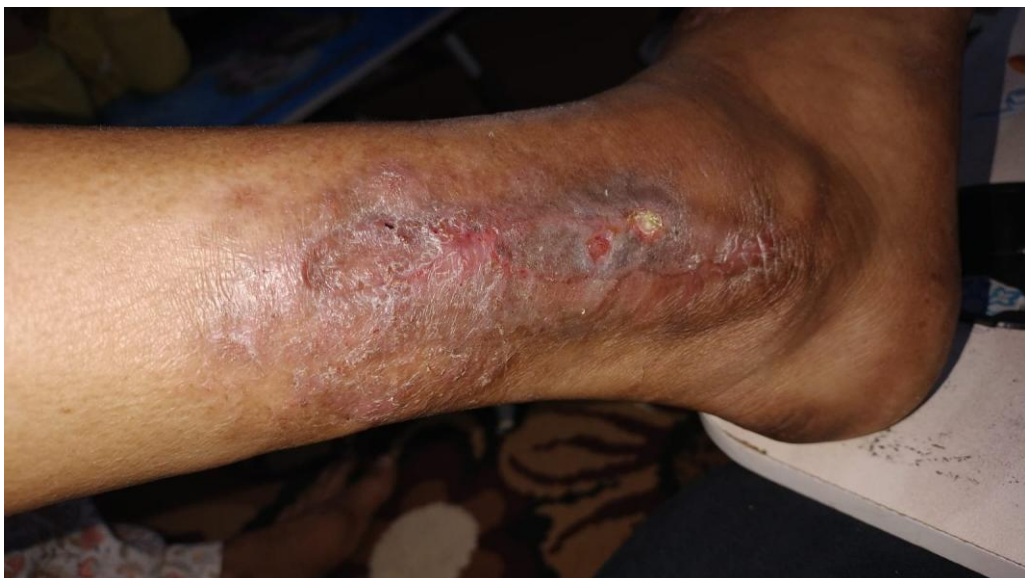
Fig 7 Progressive coverage of implant with small skin graft

- **Definitive Closure:** Following successful integration of the dermal substitute, secondary skin grafting/epithelialization was achieved.

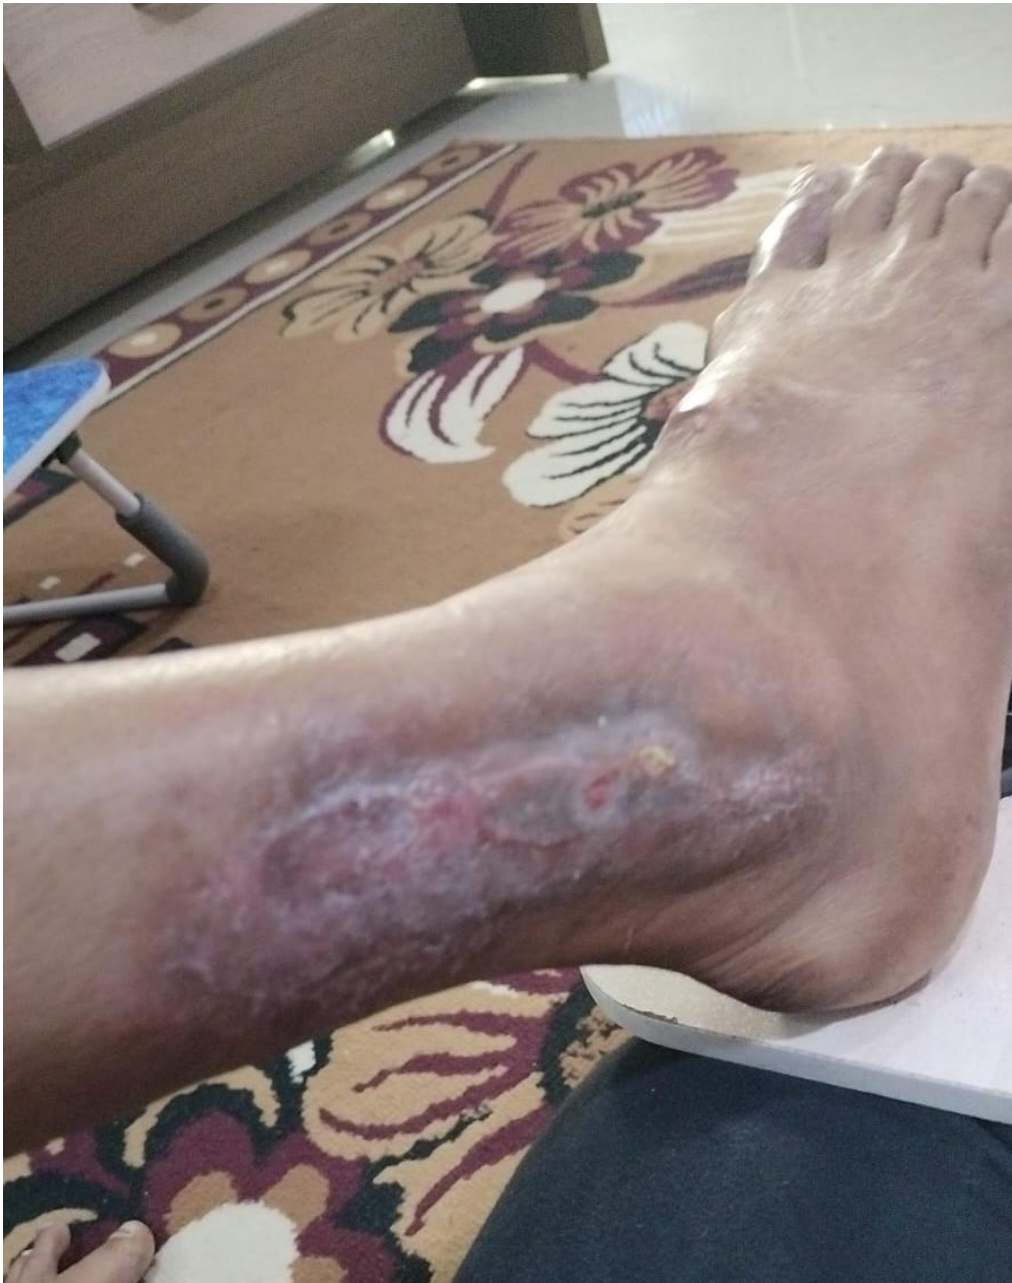
Fig 8 Late follow up show stable skin cover

exposed implant. Over a period of approximately six weeks, stable soft tissue coverage was achieved. The limb was salvaged without the need for amputation, and no recurrent infection or implant failure was observed during follow-up.
